Index No. 533306

# CERTIFICATE OF LOCATION OF GOVERNMENT CORNER

EAST QUARTER Corner of Section 32 , Township 105N , Range 13W , 5TH P.M.

STATE OF MINNESOTA, County of OLMSTED

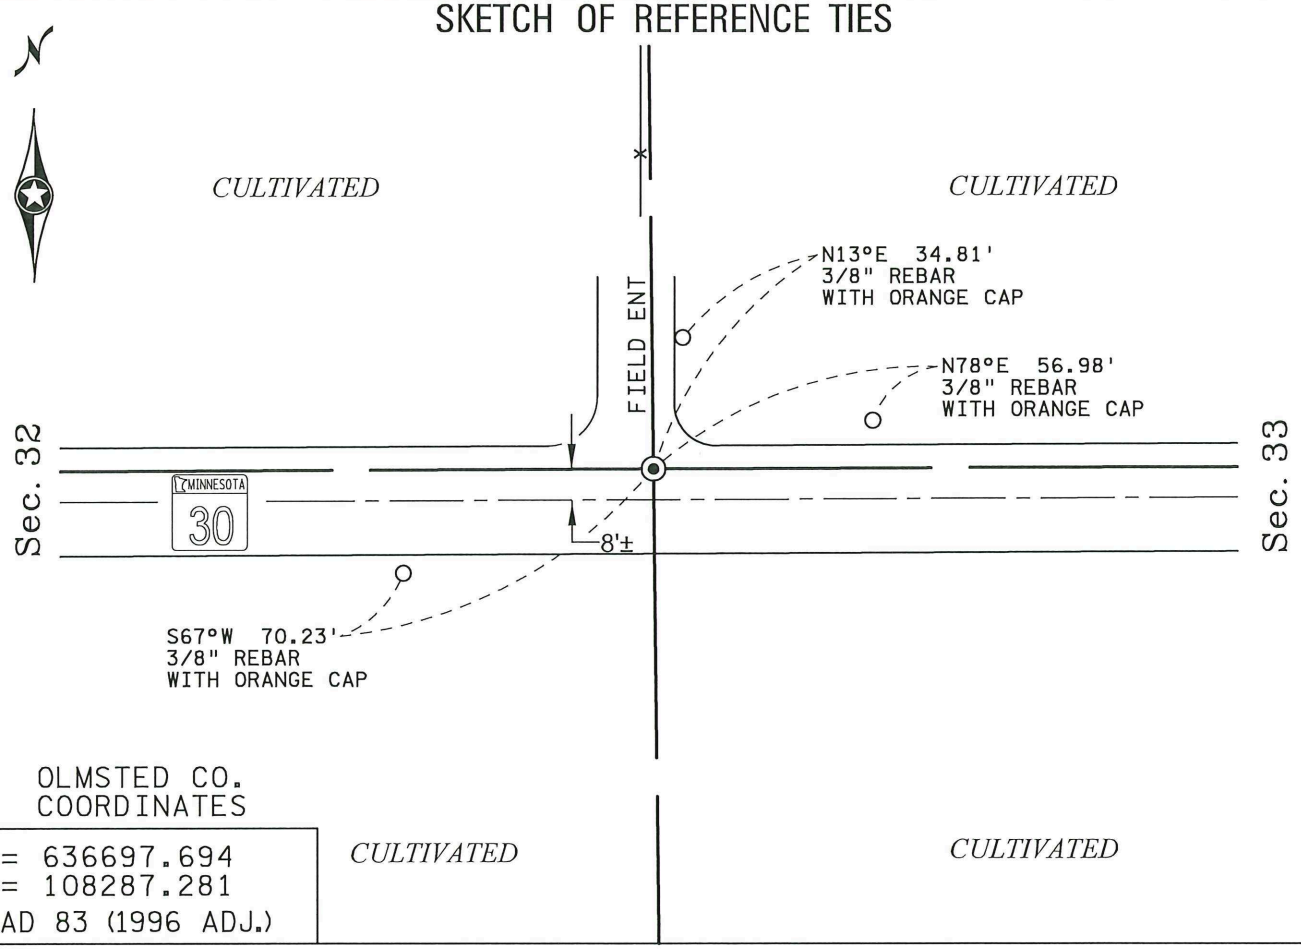
## SKETCH OF REFERENCE TIES

☒ On 08–31–2021 (DATE) found a 1" SQUARE PIPE AT SURFACE

☒ left monument as found, ☐ lowered monument, ☐ removed monument (explain)

☒ On 6–26–2026 (DATE) placed a 3" MAGSPIKE & DISK AT SURFACE ABOVE 1" PIPE AFTER ROAD CONSTRUCTION
