Index No. 651005

CERTIFICATE OF LOCATION OF GOVERNMENT CORNER

Southwest Corner of Section 10 Township 106 N Range 15 W 5th P.M.

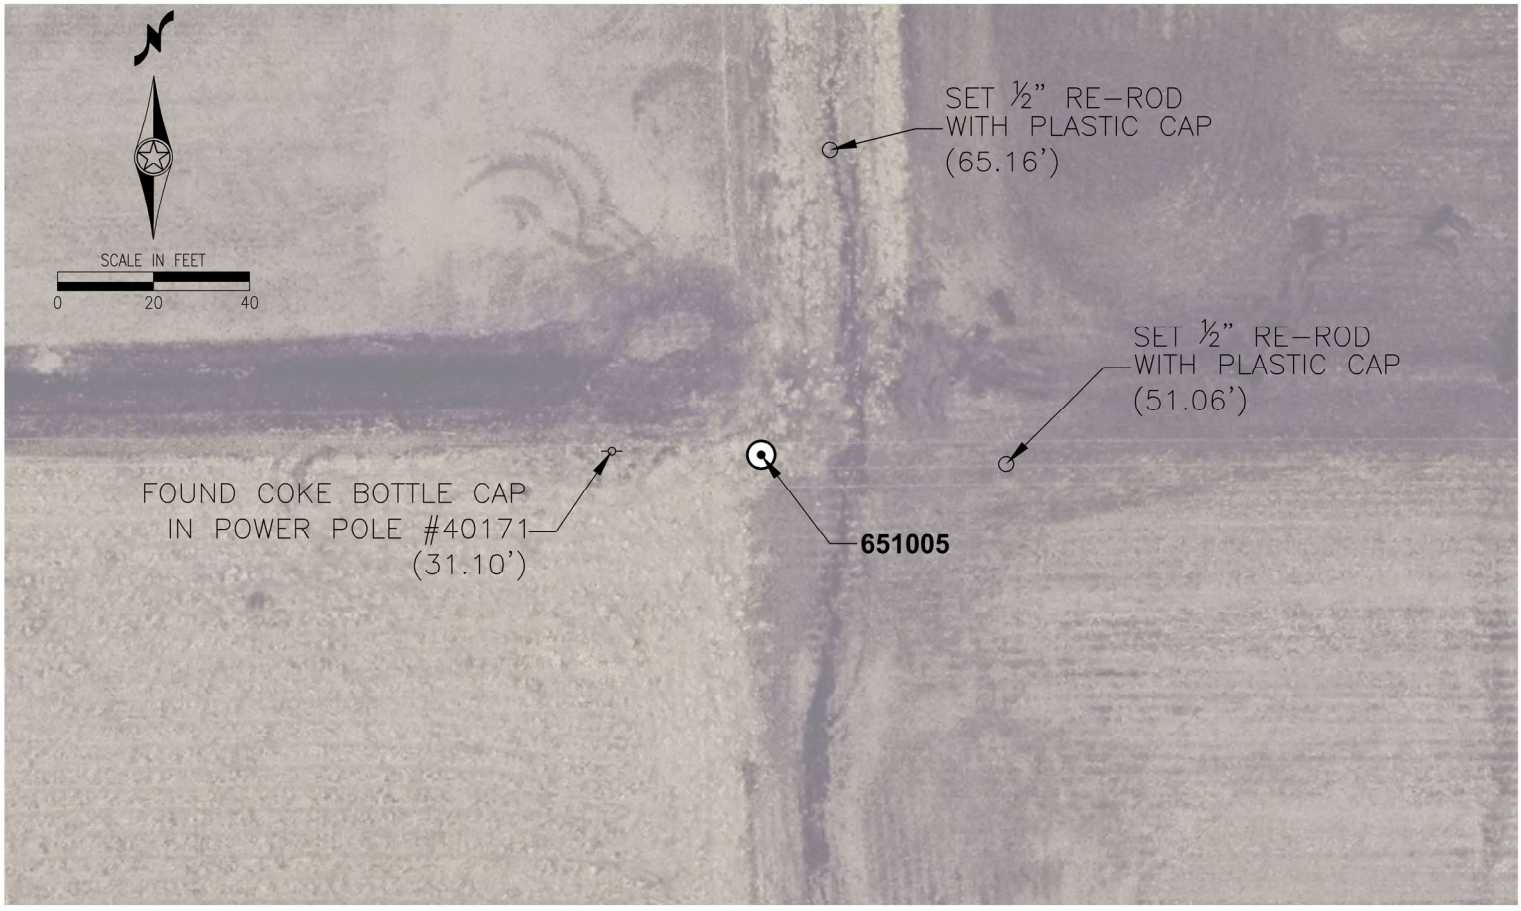
Sketch of Reference Ties

☒ On June 30, 2026 found a Cast Iron Monument (bottom), laying flat at surface. Corner disturbed during waterway reconstruction.

☐ left monument as found, ☐ lowered monument, ☒ removed monument (explain)

☒ On June 30, 2026 set a Cast Iron Cap on Telspar Pipe up 0.2 feet. Corner falls in common corner between fields.
