#512709

1/4 corner. Center 27 Elmira 105-11.

6-1872 Hunter P208 no 216 & 27. John Keefe.

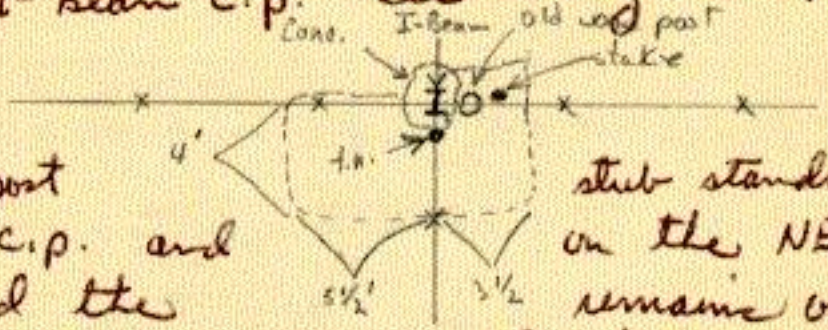
7-19-85, 1/16 North: Dug from a point 4' West of the t.n. (under east-west fence - See Drwg 25-105-11-6) for 10'+ West, 3' North, and 2½' South by 2'+ deep to clay. Found nothing.

7-19-85 Center 27: Dug as follows from the t.n (set 1' South of I-beam C.P. See Drwg 25-105-11-6):

Found an old post stub standing 1.4 east of the I-beam C.P. and on the NE side of this we found the remains of a stake approx 4" diameter with wood piece at the clay line (down 2½"). The stake hole tapered to a point about 6" into clay. The stake is approx 2.9 E and 1.95 N of the t.n. Drove a 2"x2" hub at the stake location. Hub just on the N. side of the E-W fence } LRP stake } 1.79 E 5.90 S
