#550506

1/4 Corner 5-6 Rock Dell 105-15

1/4 Cor 5-6, Rock Dell, 105-15

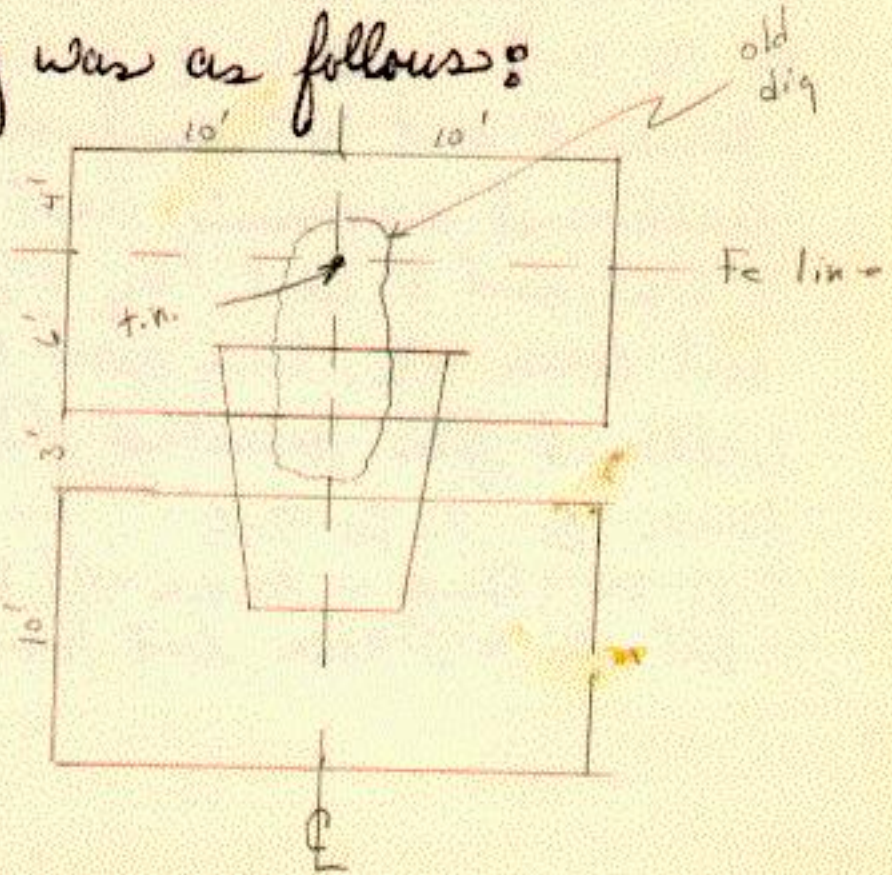
8-1984, 1/4 Cor. 5-6 : dug from the traverse nail (set in the ℄ N-S Road and in line with fences E & W) for 4' North, 6' South, 10' West and 10' East. Found the possible remains of a stake in the area 9½' East of the t.n. (two wood piece about 4"

long and 2" diameter) but could not find a hole where it could have stood. Someone had dug in the center of the road from the line of the fence, South for 7' by appx 3' wide. We were digging 3½'± deep here. The oldest road was covered with sand and there was 6" to 1' of dirt beneath it. The diggings found was beneath the road We also dug across the road from 13' to 23' South of the t.n. to cover prorated location as per Will Fraser's survey but did not find anything further → (PST 9 No 529, BK A)

Although W. Fraser does not mention the fence, it is an old property line and was doubtless there when he surveyed Therefore we will hold the N-S loc. of t.n. when cor. set.
