#6307060 (1)

1/4 Corner | West 1/4 7 | Marion | 106-13
East 1/4 12 | Rochester | 106-14

1/4 COR. W 7 MARION
E 12 ROCH

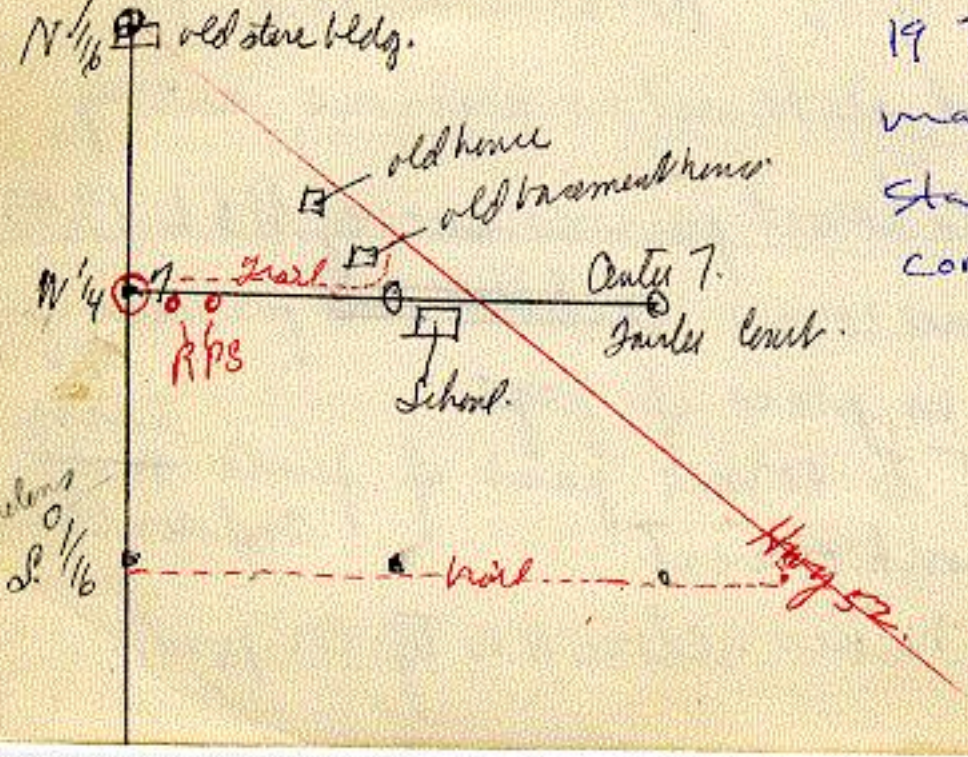
9-18 74 Hunter found stake set in previous survey at fence corner ?
-16 South found stake set previous survey M & L 19, 93 1/2

pipe in place at fence corner ~~Castillos land~~ for many years.
9-1963 set C/M in place of pipe.
- corner lies next to corner post of fence ~~north~~ east and south
no fence ~~south~~ north or west.

No Ties. Close N W Cor post.

8-21-73. sewer construction to airport running on section line - removed C/M. set hub temp cor. set 1/2" rod 100 feet east then 107.35 farther to 1/2" rod on transit line this corner tricky to locate.

19? MHD ROW map shows wooden stake at fence corner
